RE: Otsego Dam Inspection Report
Otsego Township, Allegan County, Michigan
Dam ID No. 619
SME Project No. KG59238

REPORT ON EXISTING CONDITIONS OTSEGO DAM

Inventory Identification No. 619
Hazard Potential: High
Situating along the Kalamazoo River
SW ¼ of Section 17, T1N, R12W
Otsego Township, Allegan County, Michigan
SME Project No. KG59238

Date of Inspection: April 16, 2010
Date of Report: June 3, 2010
Date of Initial Dam Safety Inspection: April 15, 2009

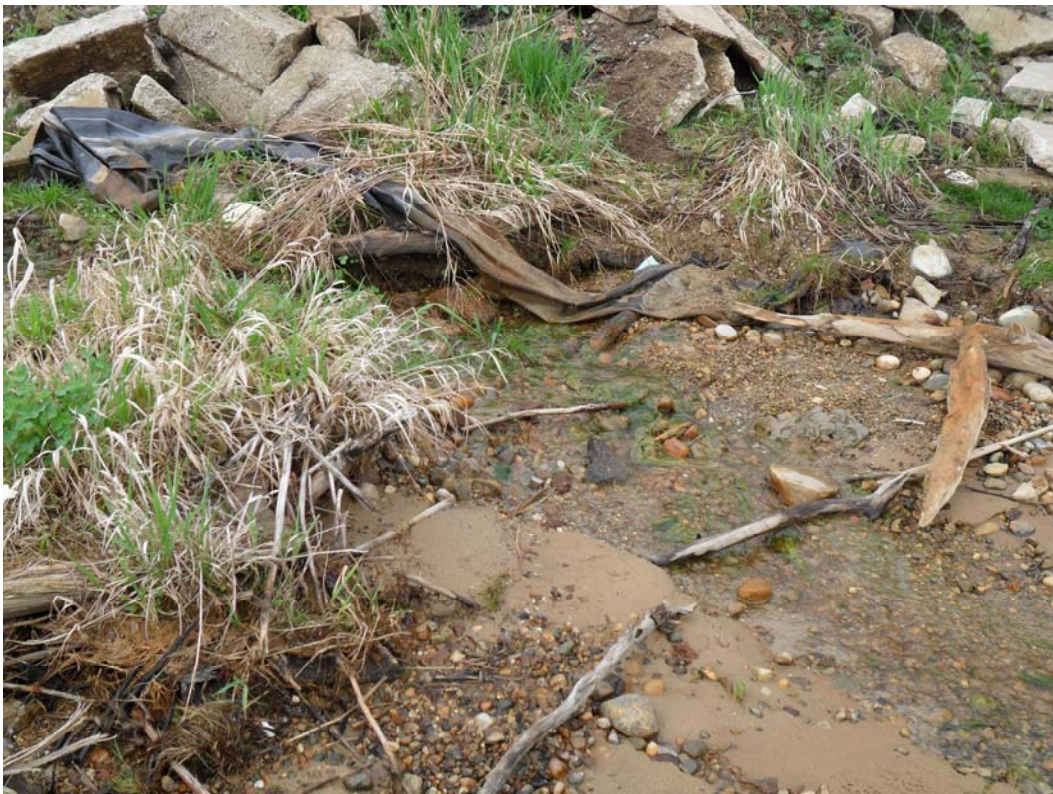
During the field inspection, seepage was observed emanating from the toe of the riverbank just downstream of the left abutment (see Photograph No. 1). This seepage did not appear to be adverse (i.e., piping was not occurring) and this seepage does not appear to be associated with flow under or through the dam. Instead, this seepage appears to be associated with groundwater flow emanating from the direction of the housing development (to the west) across River Road.

PHOTOGRAPH NO. 1: Seepage emanating from the toe of slope along the riverbank just downstream of the left embankment.

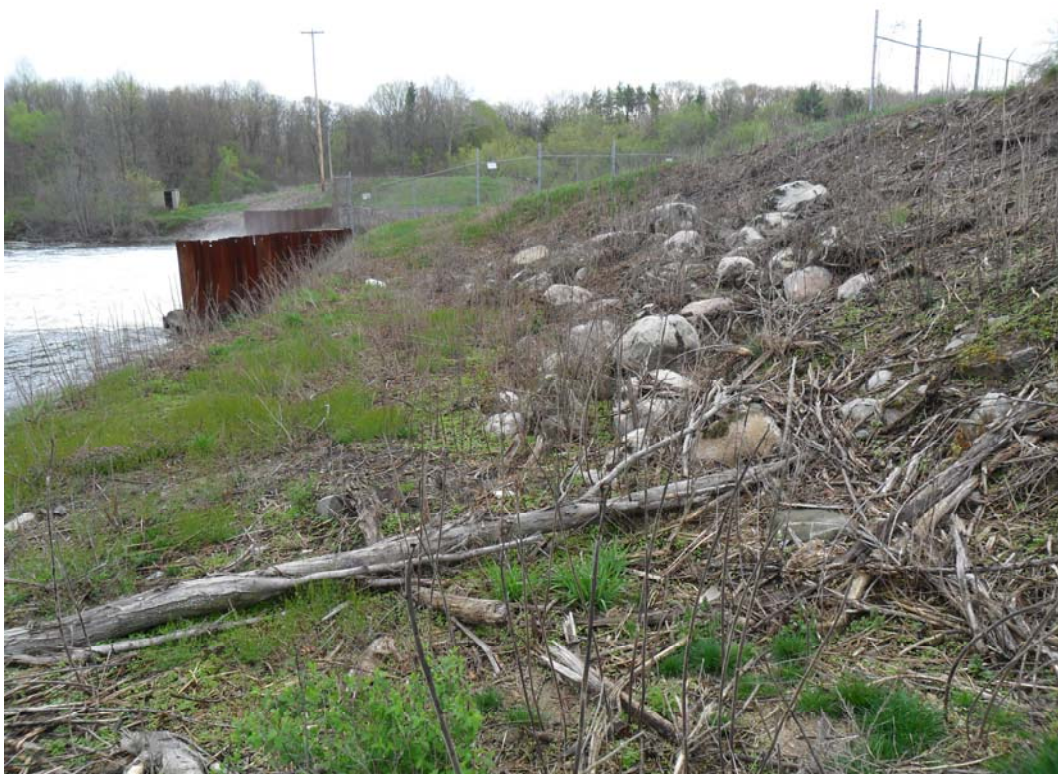
The left and right embankments were easily visible during our inspection since the vegetation remains adequately cleared (see Photograph Nos. 2, 11, 12, 13, and 14). As initially documented in our Baseline Report and further indicated in our December 2009 Inspection Report, an animal burrow is present within the left embankment just outside the security fencing (see Photograph No. 3). The current conditions at the surface of the burrow appear to be similar to the conditions documented in both our Baseline Report and our December 2009 Inspection Report. Evidence of fresh digging or recent animal activity in the burrow area was not

PHOTOGRAPH NO. 2: Looking east at the downstream slope of the left embankment.

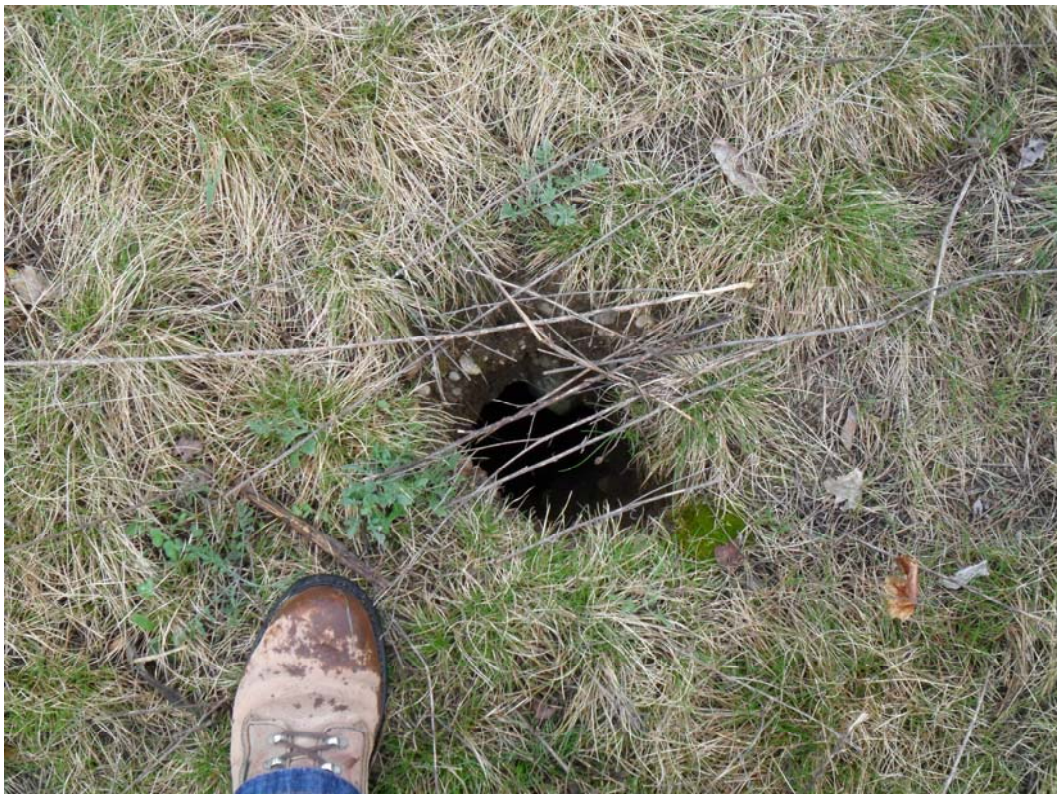
PHOTOGRAPH NO. 3: An apparent animal burrow within the left embankment just outside the security fencing.

We recommend the animal burrow on the left embankment be backfilled with soil or aggregate material. The backfill should be tamped into place as the material is placed to infill the hole. After backfilling, we recommend the condition of the burrow and the surrounding area be monitored during the weekly inspections by MDNRE staff to look for evidence of renewed burrowing activity. If additional burrowing activity is observed, trapping and removal of the animal(s) should be performed.

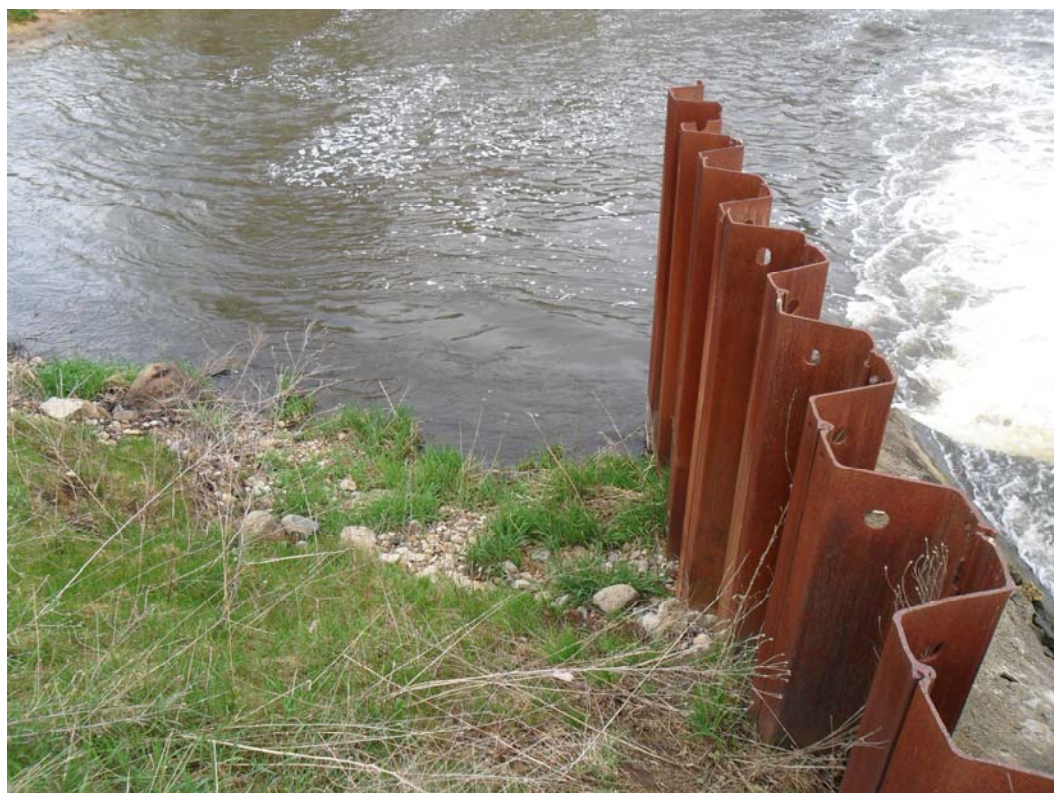
PHOTOGRAPH NO. 4: Steel sheet pile training wall at downstream end of the left spillway abutment wall.

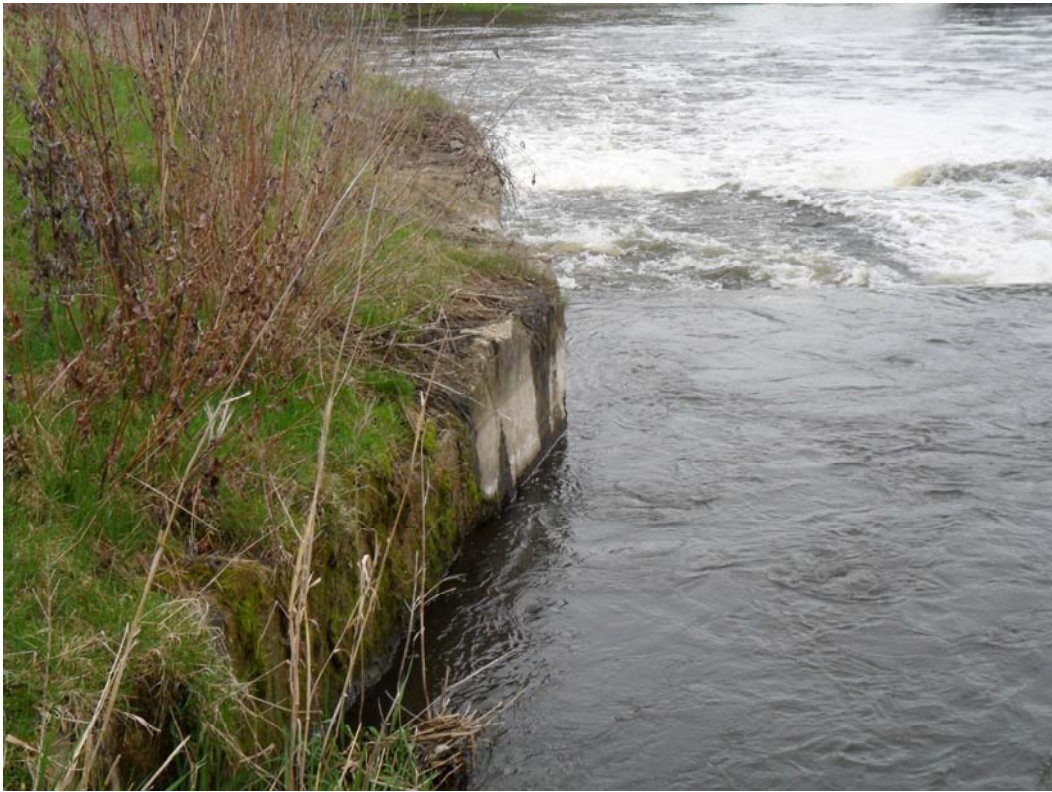
PHOTOGRAPH NO. 5: Looking downstream at flow entering the spillway along the left abutment.

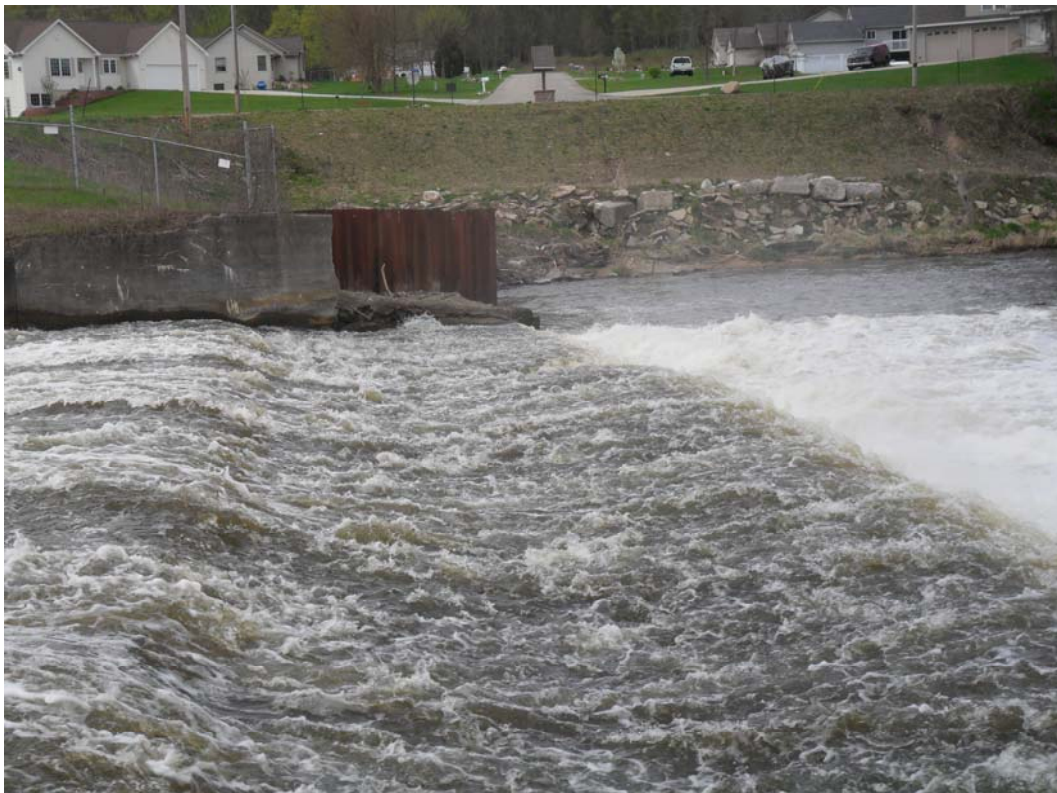
The condition of the concrete of the left and right abutments appeared similar to conditions observed during prior inspections (see Photograph Nos. 6 and 10). As indicated above, the condition of the lower spillway apron closest to the left abutment has changed since our last inspection. The downstream portion of the apron in this area appears to have tipped or rotated forward (i.e., the downstream edge has dropped). The rotated portion of the spillway apron is identified on the Otsego Dam Plan Sketch included in the Appendix and the affected area extends from the downstream edge of the spillway apron to about 12 feet upstream and from the left abutment across the spillway to about the third point of the spillway apron (see Photograph Nos. 7 and 8). A crack is present within the spillway apron at the upstream edge of where the portion of the apron has rotated. This crack was visible during our inspection near the left abutment. During previous inspections by SME, the crack was not visible due to flow conditions through the spillway. The rotated portion of the lower spillway apron can be discerned by the change in flow across this area of the apron (see Photograph No. 6).

PHOTOGRAPH NO. 6: Looking west across the lower spillway apron at the left abutment from the right abutment.

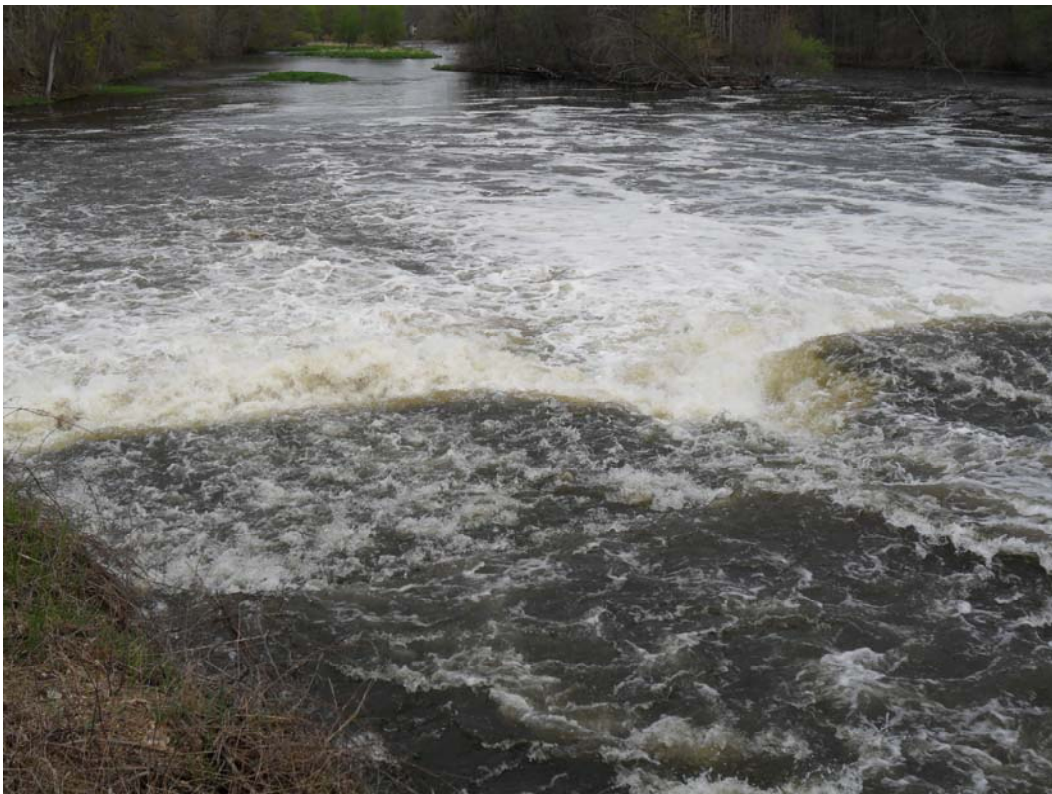
Based on our most recent inspection of the dam, there has been one discernable change to the overall condition of the dam compared to the conditions documented in our Baseline Report and in our December 2009 Inspection Report. Specifically, a cracked or broken portion of the left downstream lower spillway apron has rotated forward, i.e., the downstream edge of that portion of the spillway apron has dropped in elevation compared to its upstream edge. This observation by SME is consistent with the observations of MDNRE staff that are responsible for performing weekly inspections of the dam. The change in condition of the spillway apron in this area is evidenced by the change in the flow over the apron in this area compared to the flow across the apron toward the right abutment. We understand this change was noticed not long before the current field inspection, but an exact date of when the change occurred is unknown.

PHOTOGRAPH NO. 7: Looking at the downstream end of the lower spillway apron near the left abutment training wall. Note the broken apron.

In our opinion, the damaged or rotated spillway apron noted above cannot be repaired in-place. The condition of the spillway apron poses a threat if it were to suddenly break or erode away, leaving the remaining portion of the downstream apron unprotected and subject to rapid erosion and scour. We believe this condition can only be proactively addressed by major repairs in combination with replacement/reconstruction of a large portion of the dam or by removal of the dam. More comments about potentially reactive measures to address this condition in the event of a sudden failure of the apron are presented below in Section 4.

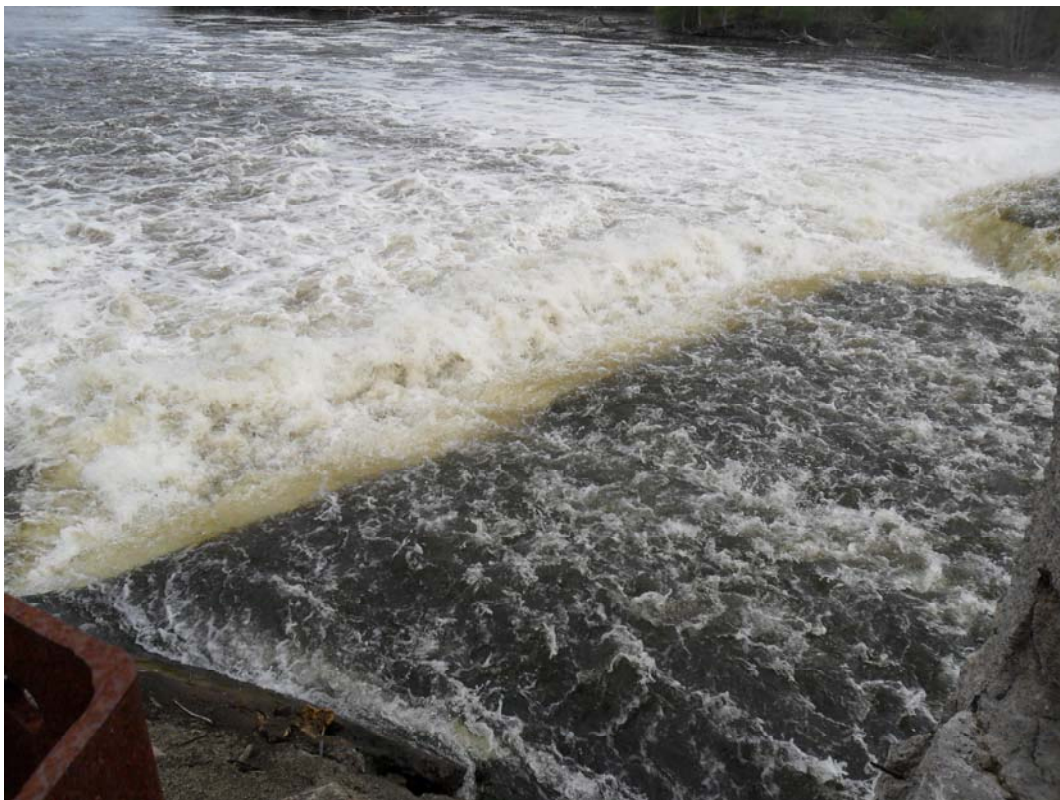
PHOTOGRAPH NO. 8: Lower spillway apron closest to left abutment. Note hole in apron to the right.

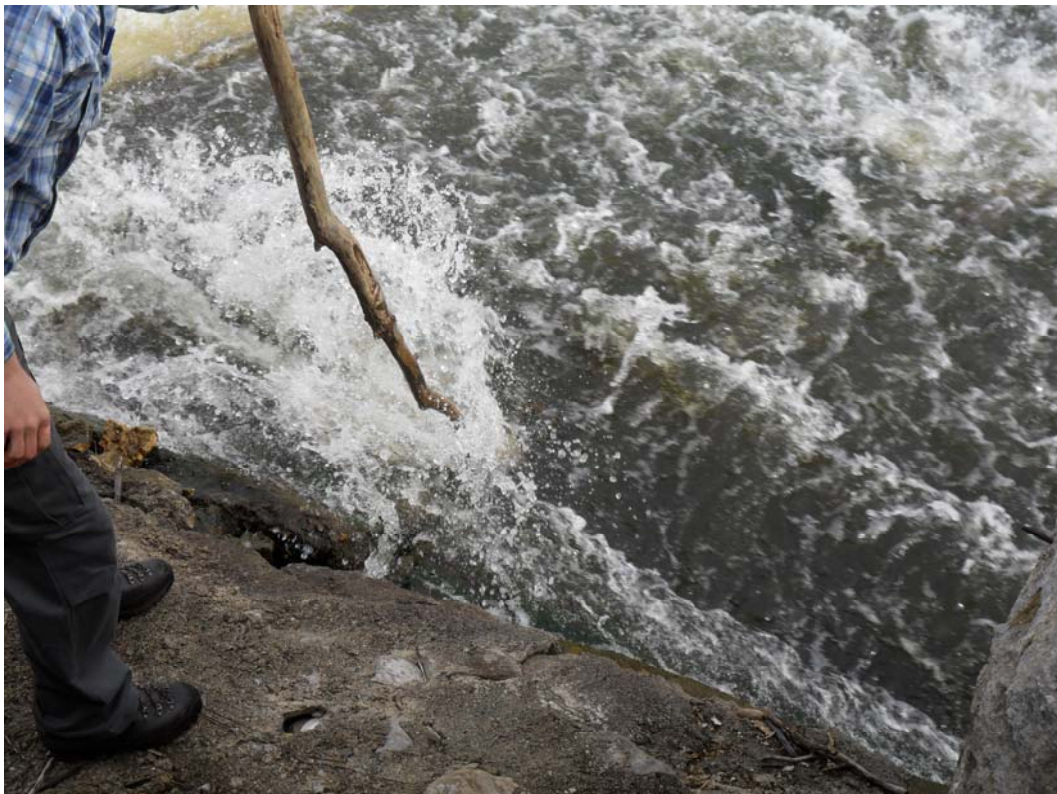
PHOTOGRAPH NO. 9: Lower spillway apron at the left abutment. Crack in apron running perpendicular to flow is being probed with the wood stick.

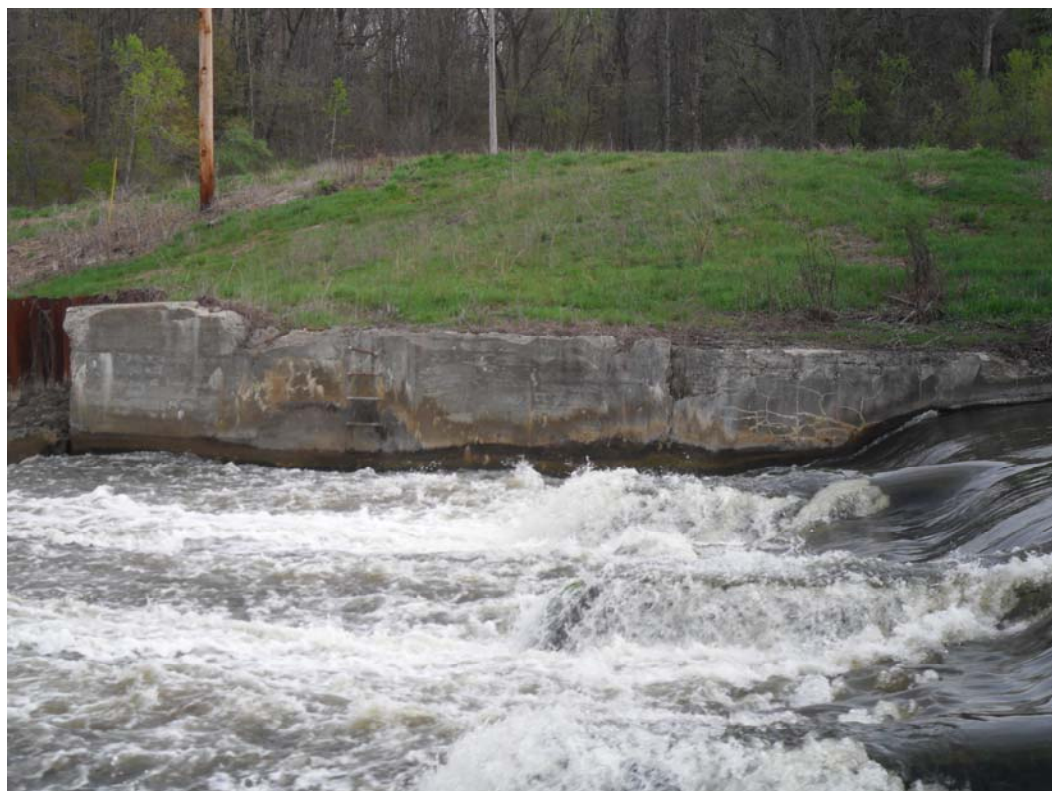
PHOTOGRAPH NO. 10: Looking east across the spillway at the right abutment.

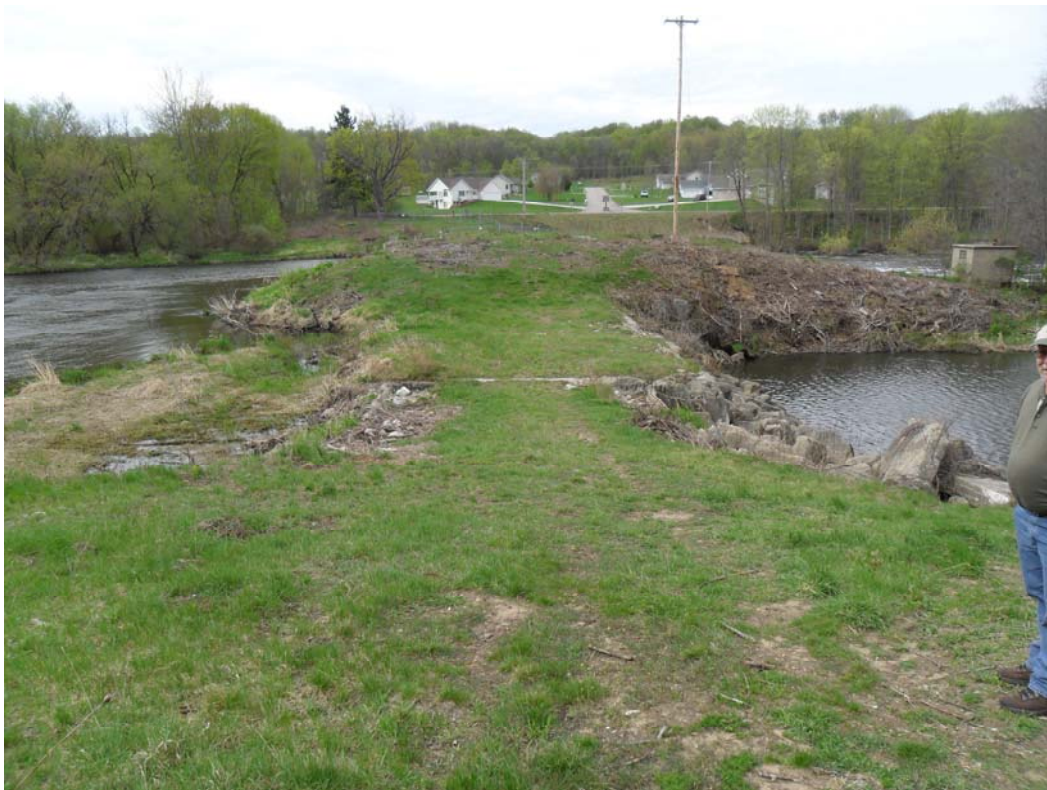
noticeable. Evidence of recent overtopping of the embankment within the former powerhouse section of the right embankment was not observed (see Photograph Nos. 11 and 14). Evidence of recent or continued erosion along both the upstream edge of the right embankment (see Photograph No. 12) and the area upstream of the left spillway training wall were also not observed (Photograph No. 5). Evidence of recent erosion along the left downstream sheet pile training wall was not present during our inspection (see Photograph No. 4). Evidence of seepage along the downstream portion of the left and right embankments was not observed.

PHOTOGRAPH NO. 11: Looking west across the right embankment toward the spillway.

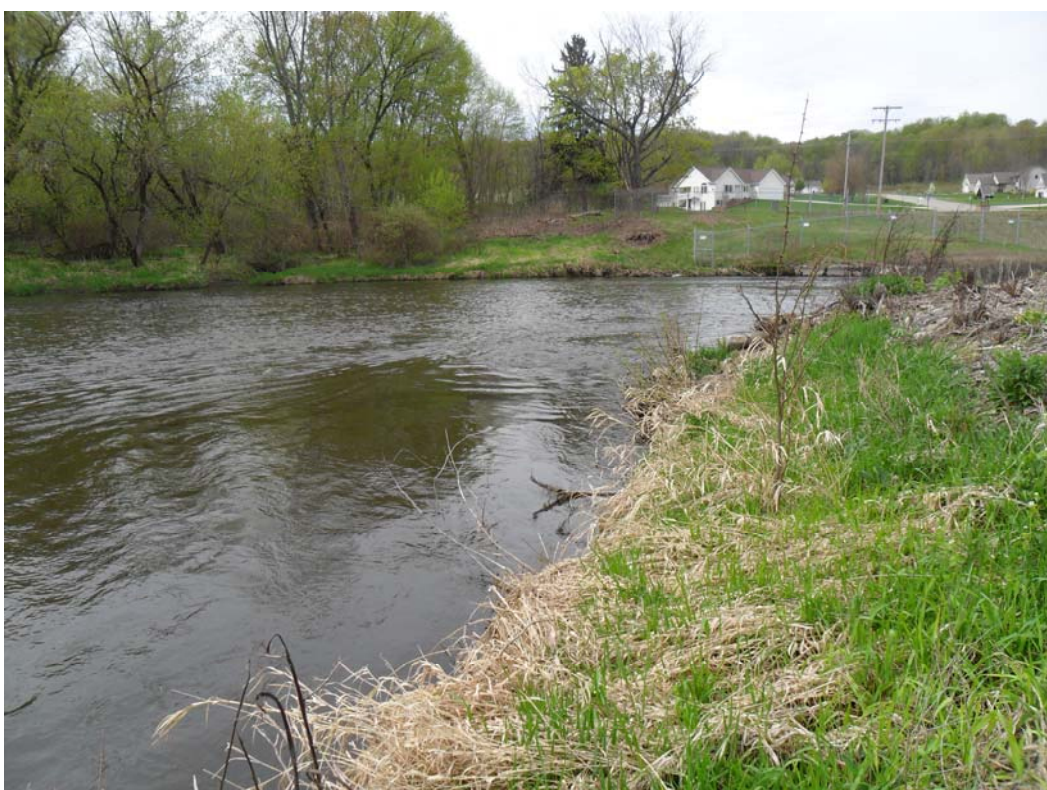
PHOTOGRAPH NO. 12: Looking west along the upstream edge of the right embankment.

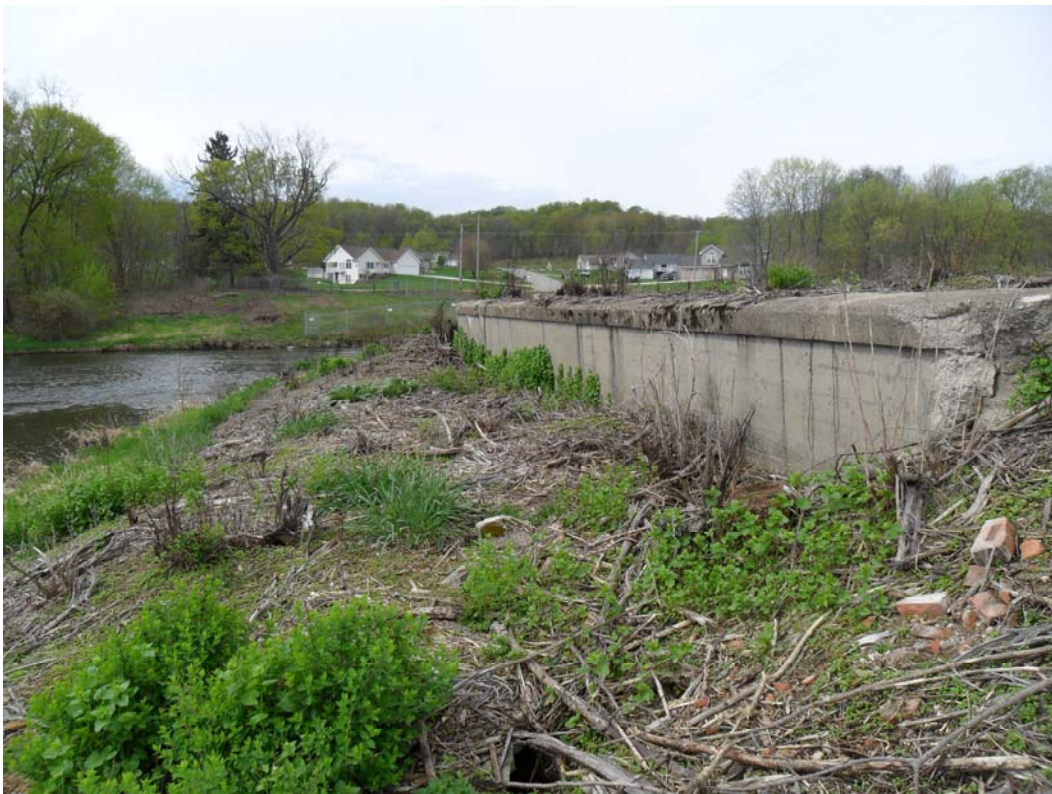
PHOTOGRAPH NO. 13: Looking west (toward the spillway) along the right embankment.

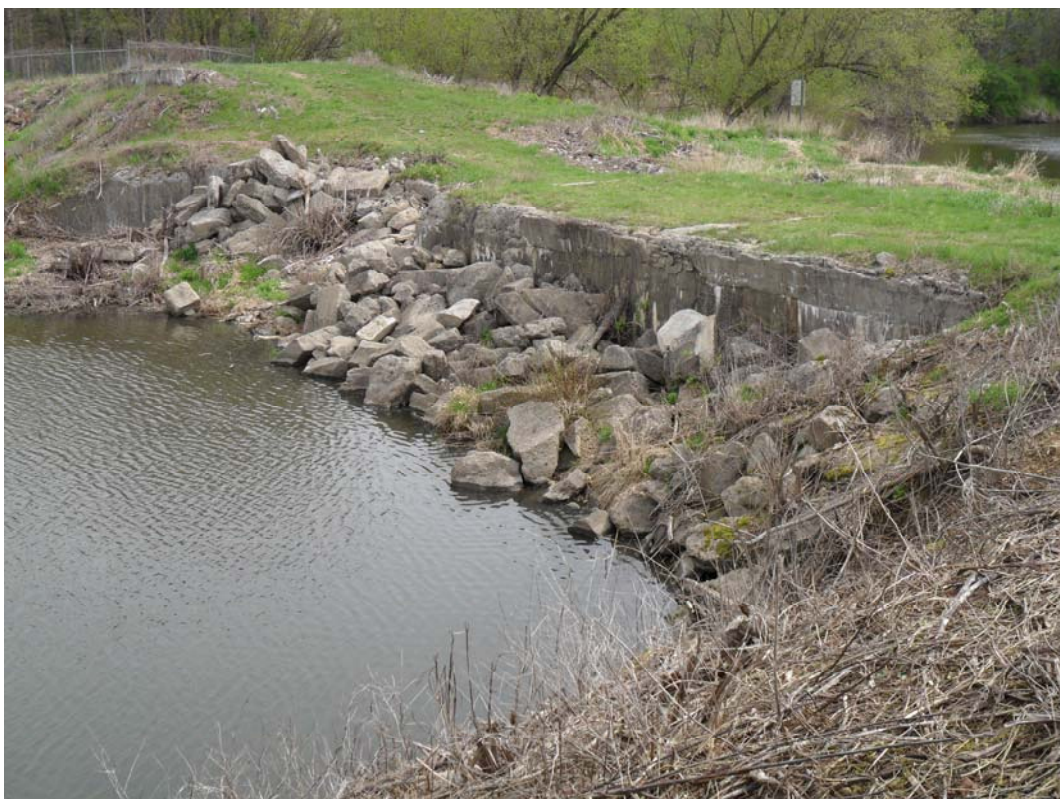
PHOTOGRAPH NO. 14: Looking at the downstream edge of the right embankment within the former powerhouse section.

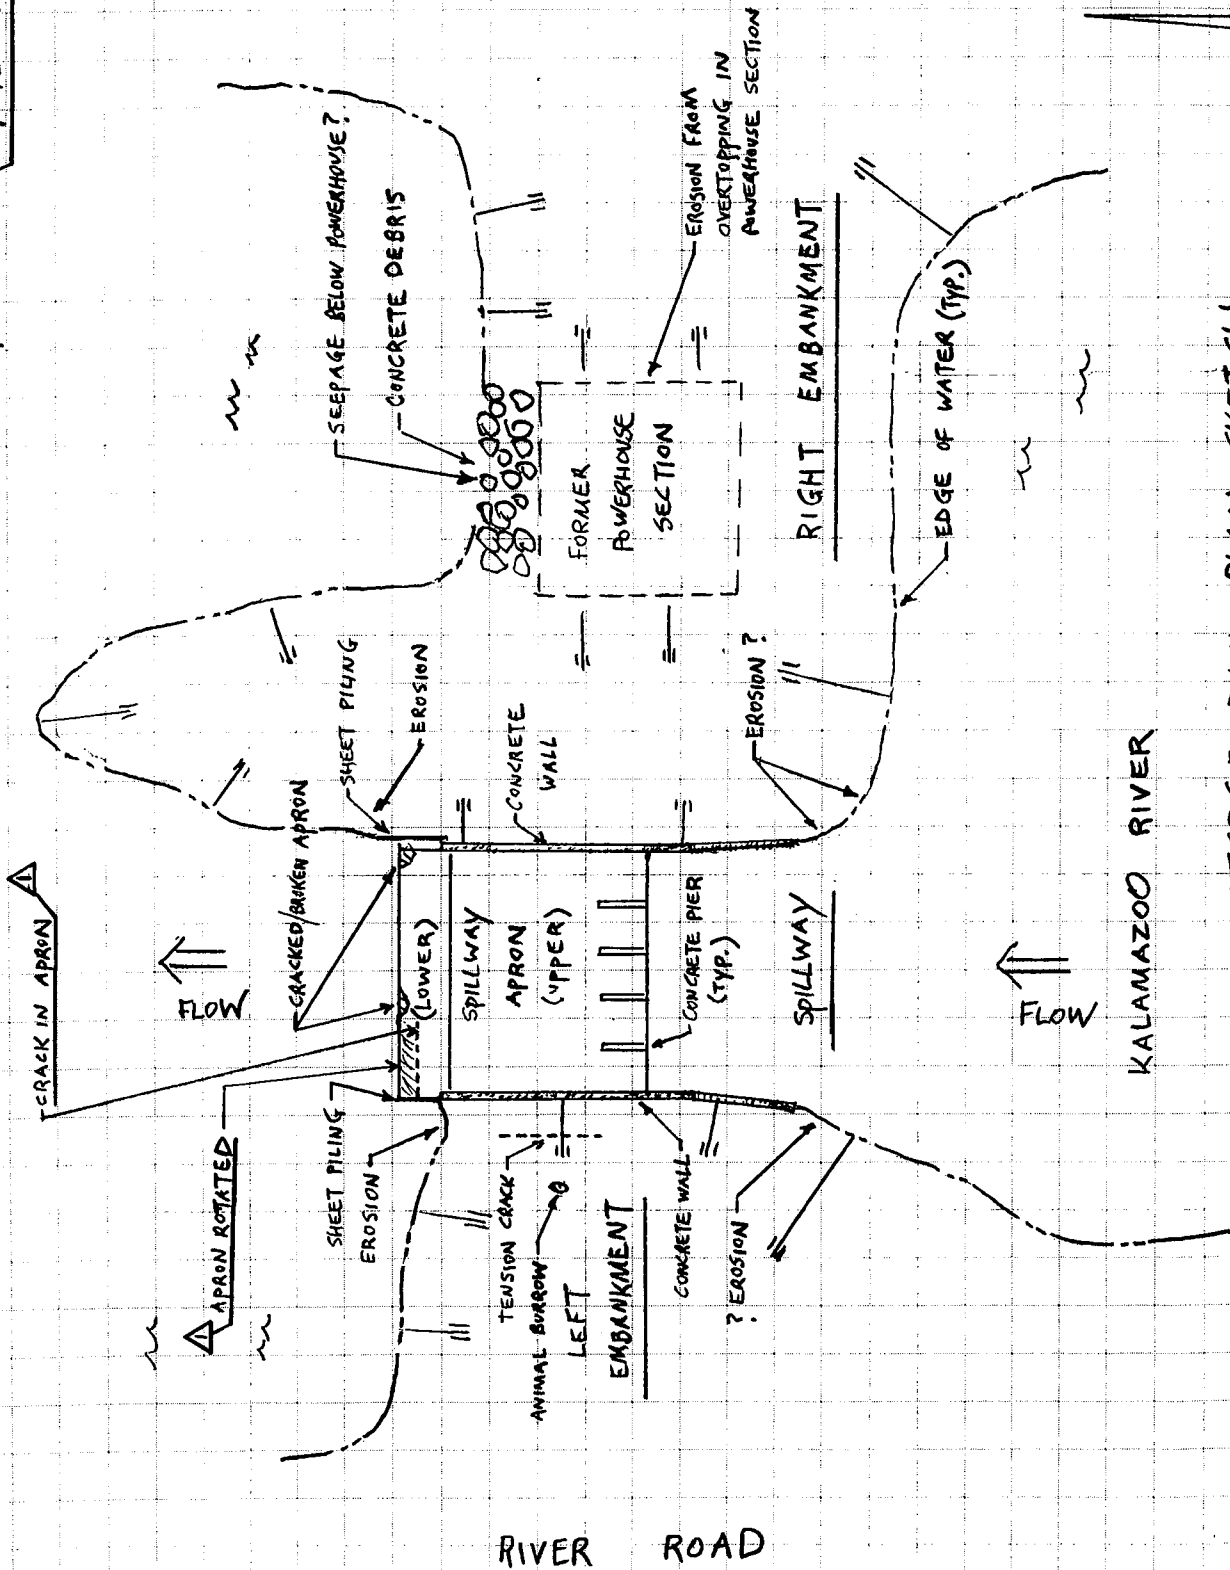
OTSEGO DAM PLAN SKETCH

The rotated portion of the spillway apron is identified on the Otsego Dam Plan Sketch included in the Appendix. The affected spillway apron extends from the downstream edge of the spillway apron to about 12 feet upstream and from the left abutment across the spillway to about the third point of the spillway apron.
